**Test Report** No.: SHAEC25003626701 **Date**: Mar 03, 2025 Page 1 of 4

Sample Name: MOS

#### **Halogen**

**Test Method:** With reference to EN 14582:2016, analysis was performed by IC.

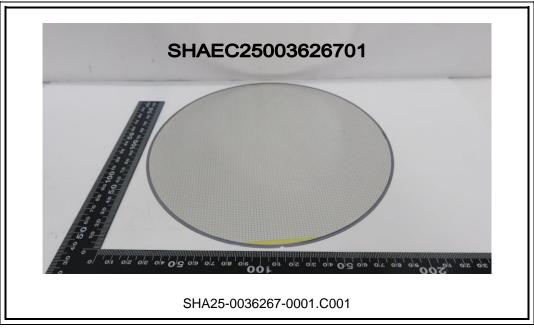
Sample Photo:

SN ID	Sample No.	SGS Sample ID	Description
SN1	A1	SHA25-0036267-0001.C001	Colorful solid
